WOOD DESTROYING PESTS AND ORGANISMS INSPECTION REPORT

#: 111713

BUILDING NO. 314	STREET LANDS END CLOSE	CITY SEA RANCH	ZIP 95497	Date of Inspection 07/07/2009	NUMBER OF PAGES 1 of 10
----------------------------	----------------------------------	--------------------------	---------------------	---	-----------------------------------

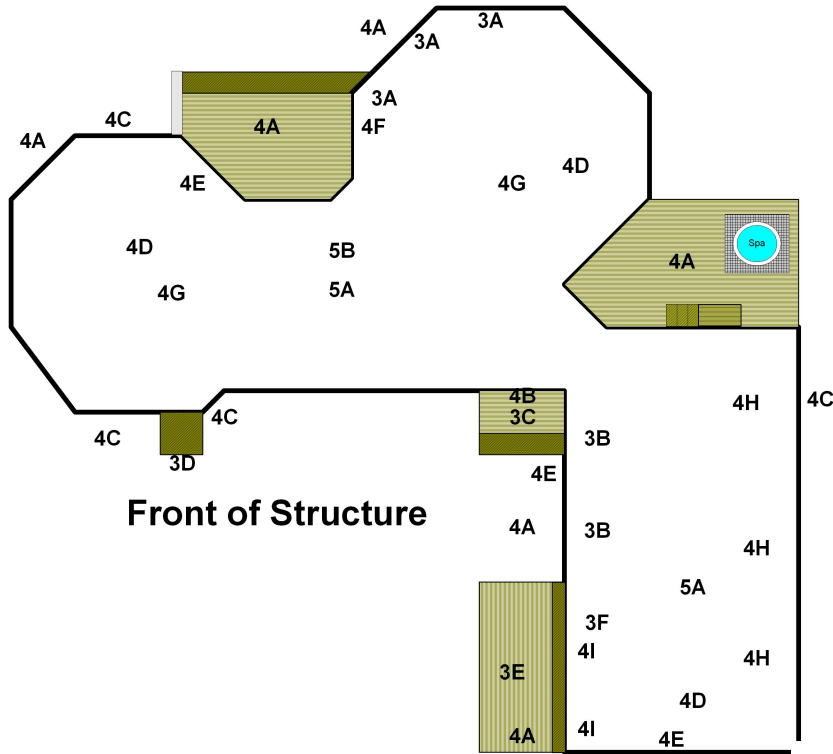
FUNGUS DAMAGE INDICATED BY 3A ON DIAGRAM. THE FUNGUS INFECTION WAS NOTED IN SHEATHING AND PORTIONS OF CRIPPLE WALL FRAMING ALONG THE SOUTH WEST END OF THE LIVING ROOM .

FUNGUS DAMAGE WAS NOTED TO FLOORS AND JOISTS WITH INDICATIONS OF POSSIBLE FURTHER DAMAGE UP IN WALL AREAS DUE TO PLUMBING LEAKS AT TUBS AND LEAKAGE AT TUB SURROUNDS AT HALL AND MASTER BATHROOMS .

FUNGUS DAMAGE NOTED TO FRONT ENTRY PORCH AREA AS INDICATED BY 3C ON DIAGRAM. THE DAMAGE WAS IN DOUG FIR JOISTS AND MOST OF DECKING .

FUNGUS DAMAGE INDICATED BY 3D ON DIAGRAM. THE FUNGUS INFECTION WAS NOTED IN FRAMING AND DECKING AT THE SMALL EAST PORCH .

FUNGUS DAMAGE NOTED TO DECK AREAS AS INDICATED BY 3E ON DIAGRAM. THE DAMAGE WAS IN DECKING AND JOISTS AT THE MASTER BEDROOM DECK .

FUNGUS DAMAGE TO FLOOR AND RIMJOIST DUE TO LEAKAGE AT SLIDING GLASS DOOR AS INDICATED BY 3F AT THE MASTER BEDROOM. INDICATIONS OF FURTHER DAMAGE UP IN WALL AREAS WITH VISIBLE MOISTURE DAMAGE TO SHEETROCK DUE TO LEAKAGE .

EXTERIOR SIDING FOUND WEATHERED ALONG THE SOUTH AND EAST SIDES AS INDICATED BY 4A ON THE DIAGRAM. VOIDS COULD POTENTIALLY ALLOW AN EXCESSIVE MOISTURE CONDITION TO OCCUR TO INTERIOR WALL FRAMING.

SIDING WAS FOUND IN EARTH CONTACT OR LACKS PROPER CLEARANCE
AS INDICATED BY 4C ON THE DIAGRAM. THE CONTACT OR LACK OF
PROPER CLEARANCE WAS AT THE FRONT AND OCEAN SIDE .

WATER STAINS NOTED IN CEILING AREA AS INDICATED BY 4D ON THE
DIAGRAM. INSPECTION WAS MADE DURING DRY WEATHER AND
DETERMINATION OF PRESENT LEAKS COULD NOT BE MADE AT THIS TIME.

DUAL PANE WINDOW SEALS APPARENTLY HAVE FAILED AT WINDOWS AS
INDICATED BY 4E ON THE DIAGRAM. MANY OF THE WINDOW FRAMES
APPEARS WORN AND IN NEED OF REPAIR OR REPLACEMENT.

INSULATION IN THE SUBAREA AS INDICATED BY 4G ON THE DIAGRAM WAS FOUND TO BE FALLING DOWN WHICH BLOCKS PORTION OF THE AIR FLOW VITAL FOR PROPER CROSS VENTILATION. INSULATION HAS BEEN PULLED DOWN BY PAST VERMIN IN THE SUBAREA. SEVERAL OF THE HEATING DUCTS HAVE ALSO BEEN DAMAGED.

WOOD BORING BEETLE INFESTATION AS INDICATED BY 4H ON DIAGRAM. THE BEETLES ARE IN JOIST(S), SUBAREA FRAMING AT THE EAST SIDE SUBAREA.

ATTIC WAS INACCESSIBLE DUE TO ENCLOSED CEILING AS INDICATED BY 5B ON THE DIAGRAM. NO VISIBLE ADVERSE CONDITIONS NOTED ON INTERIOR CEILINGS AT THIS TIME.

REMOVE EXTERIOR SIDING, REMOVE AND REPLACE ALL DAMAGED MATERIAL. IF FURTHER CONDITIONS ARE FOUND DURING REPAIRS, ISSUE SUPPLEMENTAL REPORT AND PRICE TO COMPLETE. INSTALL NEW SIDING IN REPAIRED AREA.

REMOVE THE SINKS, TOILETS, TILE FLOORS, TUB SURROUNDS, REMOVE TUBS, REMOVE AND REPLACE THE FUNGUS DAMAGED MATERIAL CHECKING THE WALL AREAS FOR FURTHER CONDITIONS. IF FURTHER CONDITIONS ARE FOUND A SUPPLEMENTAL REPORT AND PRICE TO COMPLETE WILL BE ISSUED. REINSTALL TUBS, CONNECT PLUMBING AND CORRECT ALL LEAKS. INSTALL NEW TILE BACKER AND INSTALL NEW FLOOR AND SURROUND TILE OF MEDIUM QUALITY AND PRICE. REINSTALL THE SINKS AND TOILETS UNLESS OWNER PROVIDES NEW SINK VANITIES AND TOILETS. INSTALL NEW SHEETROCK AS NEEDED, REPAINT BATHROOMS AFTER REPAIRS COMPLETED. PRICE ADJUSTMENTS TO BE MADE IF OWNER WANTS TO UP OR DOWN GRADE MATERIALS USED.

REMOVE AND REPLACE THE PORCH WITH NEW GROUND CONTACT PRESSURE TREATED WOOD AND DECKING WITH NEW SELECT REDWOOD DECKING.

REMOVE AND REPLACE ALL DAMAGED MATERIAL. IF FURTHER CONDITIONS ARE FOUND DURING REPAIRS, ISSUE SUPPLEMENTAL REPORT AND PRICE TO COMPLETE.

REMOVE AND REPLACE THE DECK AREA AS NOTED DUE TO THE AMOUNT OF DAMAGE AND SOME OF THE MATERIALS USED ARE NOT DECAY RESISTANT. NEW MATERIAL SHOULD BE PRESSURE TREATED AND REDWOOD, OR TREX DECKING UPON REQUEST. IF FURTHER CONDITIONS ARE FOUND DURING REPAIRS A SUPPLEMENTAL REPORT WILL BE ISSUED. OLD DECK TO BE REMOVED AND DISPOSED. NOTE: OWNER MAY WISH TO EMPLOY OTHER FIRM TO REPAIR DECK AND USE SOME OF THE EXISTING MATERIAL WHICH IS NOT DAMAGED. THIS METHOD WOULD REDUCE COST SOMEWHAT AT THIS TIME.

REMOVE AND REPLACE THE DAMAGED MATERIAL, CHECKING THE WALL AREA FOR FURTHER CONDITIONS, IF FOUND, ISSUE A SUPPLEMENTAL REPORT. INSTALL A NEW SHEETMETAL PAN UNDER THE SLIDING GLASS DOORS FOR FUTURE MOISTURE PROTECTION. IF FURTHER INFORMATION DESIRED ABOUT CONDITION OF SLIDER FRAMES, THE OWNER IS TO EMPLOY WINDOW OR GLASS FIRM TO REPAIR OR REPLACE SLIDING GLASS DOORS AS NEEDED. IF FLOOR COVERINGS ARE DISTURBED DURING REPAIRS, OWNER TO EMPLOY FLOORING FIRM AS NEEDED. REPAINT SHEETROCK WALL.

OWNER OR CONTRACTOR SHOULD BE EMPLOYED TO CORRECT AND REPAIR AS NEEDED FOR PROPER MOISTURE PROTECTION. OWNER TO KEEP STRUCTURE SEALED WITH STAIN TO AVOID FUNGUS DAMAGE AND REDUCE CHANCES FOR INFESTATIONS.

LOWER THE GRADE TO EXPOSE THE FOUNDATION BY AT LEAST (6)
INCHES AND CHECK THE SIDING FOR FURTHER CONDITIONS, IF FOUND,
ISSUE A SUPPLEMENTAL REPORT AND PRICE TO COMPLETE.

WE RECOMMEND TO EMPLOY A LICENSED ROOFER.

EMPLOY WINDOW FIRM TO INSPECT AND REPAIR OR REPLACE WINDOWS
AS NEEDED.

EMPLOY PROPER FIRM TO REPAIR/REPLACE OR REMOVE INSULATION AS NEEDED TO ALLOW FOR PROPER AIR MOVEMENT. CONTACT HEATING AND AIR FIRM TO REPAIR OR REPLACE DAMAGED DUCTING.

WE DO NOT BELIEVE THE INFESTATION EXTENDS UP INTO THE WALL AREAS HOWEVER PER STRUCTURAL PEST CONTROL BOARD, THE MOST ASSURED WAY TO ERADICATE WOOD BORING BEETLES IS TO FUMIGATE THE STRUCTURE WITH A FUMIGANT LETHAL TO WOOD BORING BEETLES. SEE THE OCCUPANTS FUMIGATION NOTICE FOR FURTHER DETAILS REGARDING PREPARATION. THIS COMPANY IS NOT RESPONSIBLE FOR DELAYS OR SCHEDULE CHANGES DUE TO INCLEMENT WEATHER OR OTHER AGENCIES, NOR IS IT RESPONSIBLE FOR DAMAGE TO ROOF OR PLANTS AS A RESULT OF THE FUMIGATION. REFER TO THE OCCUPANT'S FUMIGATION NOTICE/PREPARATION SHEET (SENT SEPARATELY) FOR ADDITIONAL INFORMATION. FUMIGATION IS WARRANTIED FOR TWO YEARS FOR TARGET PEST. NEW COST INCREASES ARE NECESSARY TO OFFSET COST OF USING VIKANE AT INCREASED RATES TO ERADICATE WOOD BORING BEETLES.

IF FURTHER INFORMATION IS DESIRED WE RECOMMEND FURTHER INSPECTION AFTER INSPECTION HOLES INSTALLED IN CEILING. EMPLOY ROOFER FOR OTHER INFORMATION REGARDING ROOFING OR CONSTRUCTION.
