WOOD DESTROYING PESTS AND ORGANISMS INSPECTION REPORT

#: 111713

BUILDING NO. 314	STREET LANDS END CLOSE	CITY SEA RANCH	ZIP 95497	Date of Inspection 07/07/2009	NUMBER OF PAGES 1 of 10
----------------------------	----------------------------------	--------------------------	---------------------	---	-----------------------------------

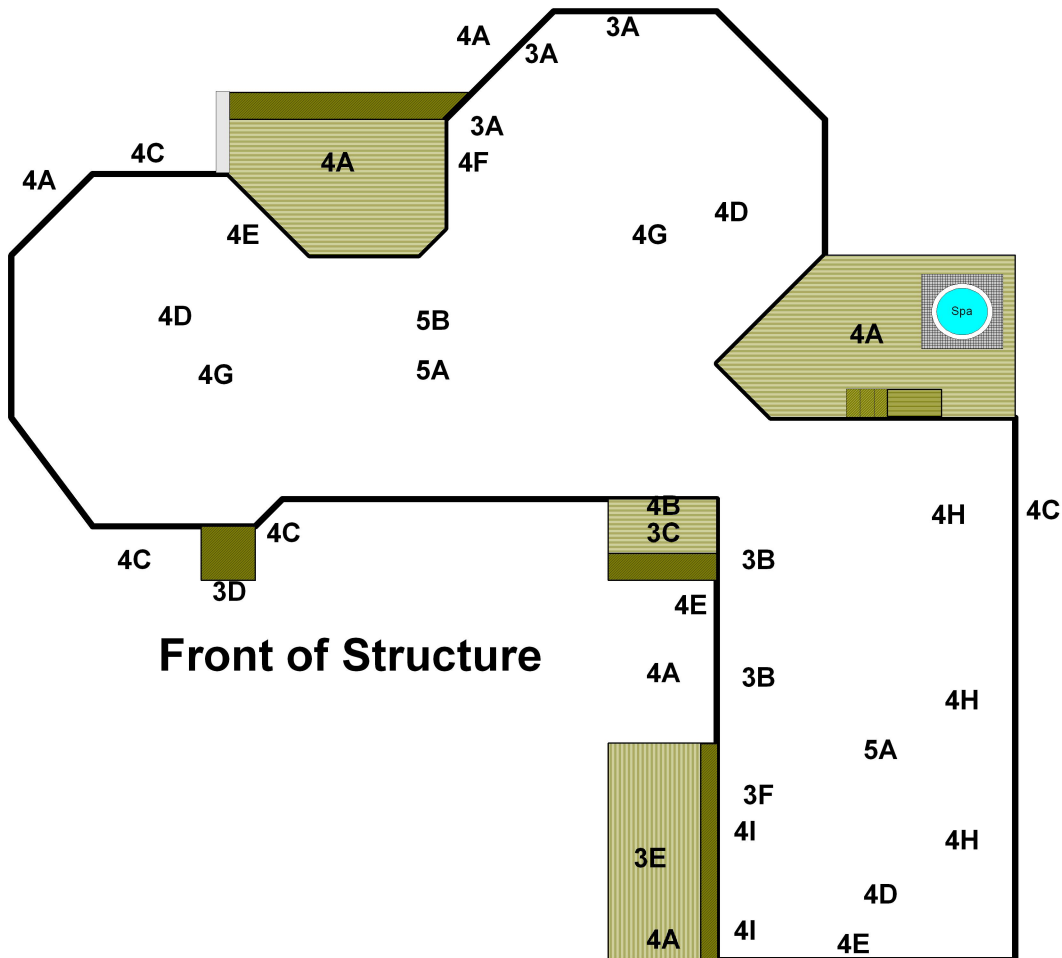
ATTIC WAS INACCESSIBLE DUE TO ENCLOSED CEILING AS INDICATED BY 5B ON THE DIAGRAM. NO VISIBLE ADVERSE CONDITIONS NOTED ON INTERIOR CEILINGS AT THIS TIME.

IF FURTHER INFORMATION IS DESIRED WE RECOMMEND FURTHER INSPECTION AFTER INSPECTION HOLES INSTALLED IN CEILING. EMPLOY ROOFER FOR OTHER INFORMATION REGARDING ROOFING OR CONSTRUCTION.
